Research Report  
301

**EVALUATION OF CORED SPECIMENS FROM  
TIMBER CAISSON BENEATH PIER NO. 2  
OF THE US 25 BRIDGE OVER  
THE OHIO RIVER BETWEEN COVINGTON AND  
CINCINNATI  
F141(1)**

Division of Research  
DEPARTMENT OF HIGHWAYS  
Commonwealth of Kentucky

December 1970

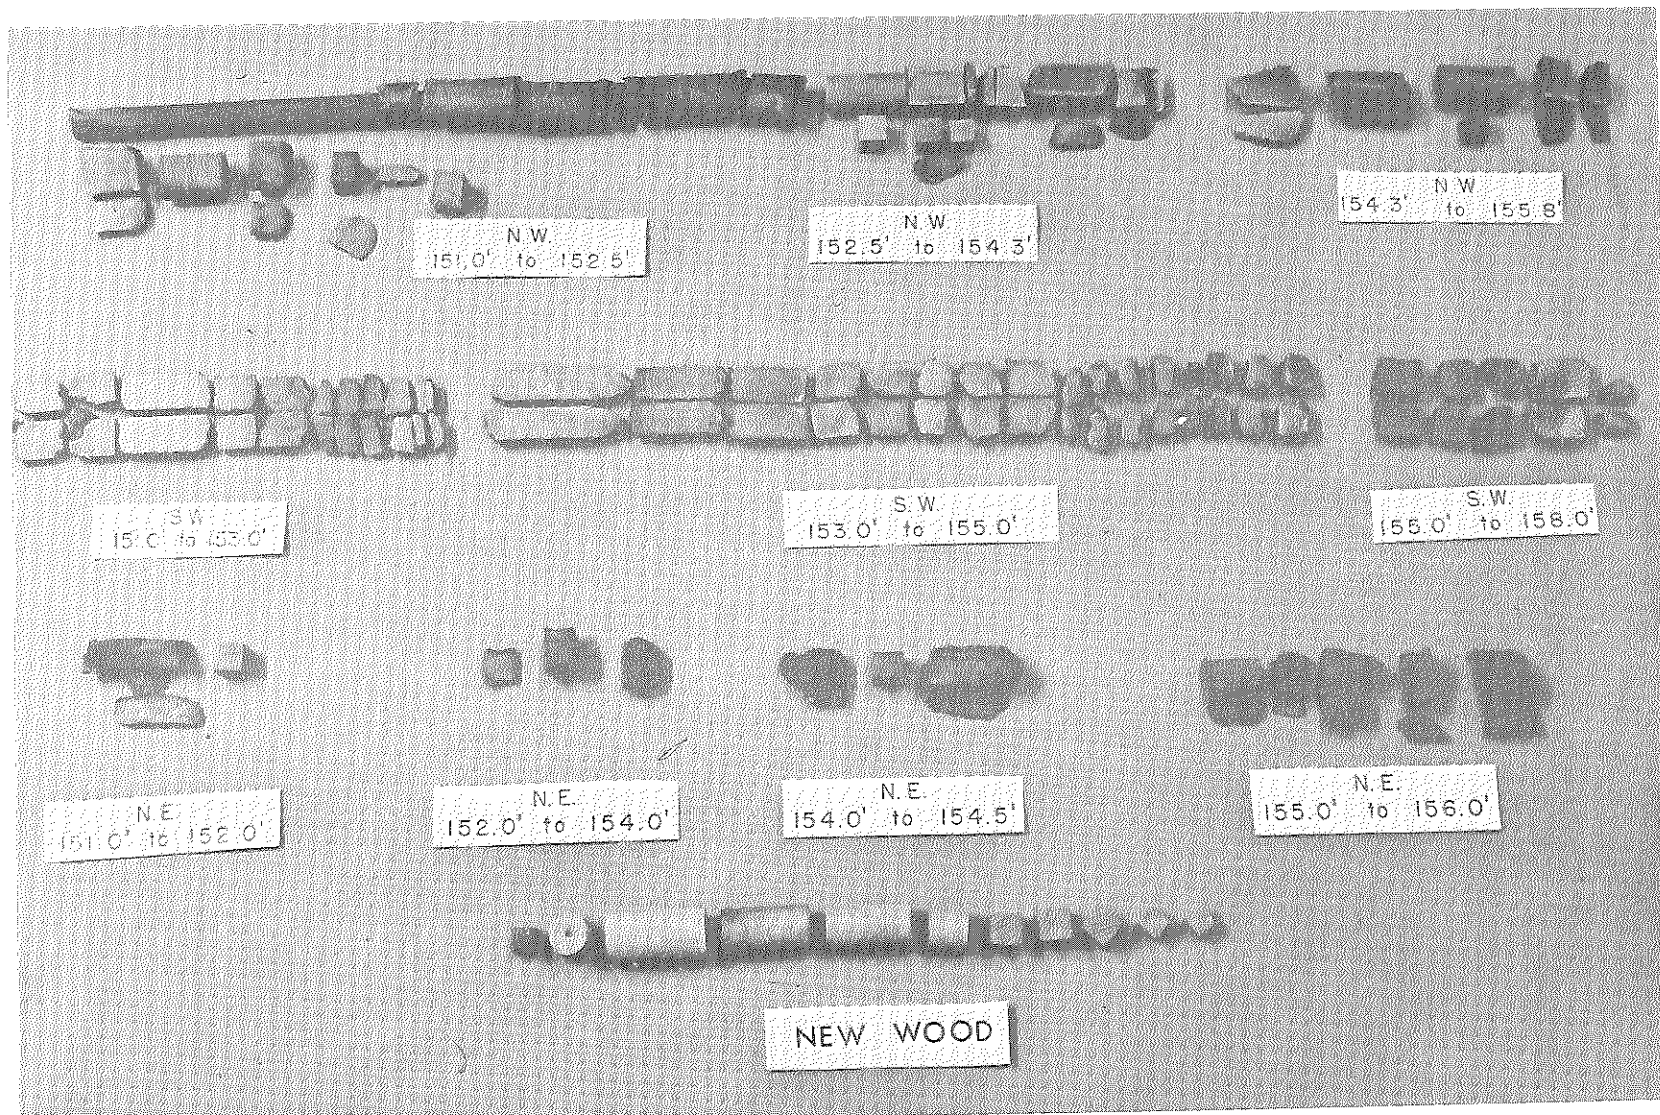
Figure 1 is a composite photograph of the three cores received for evaluation. Attention is directed to the incidental recovery of a wrought iron pin in the upper portion of the NW core.

Fig. 1: Composite Photo of Cores Received for Evaluation. Recovery of wrought iron pin in NW core was incidental.

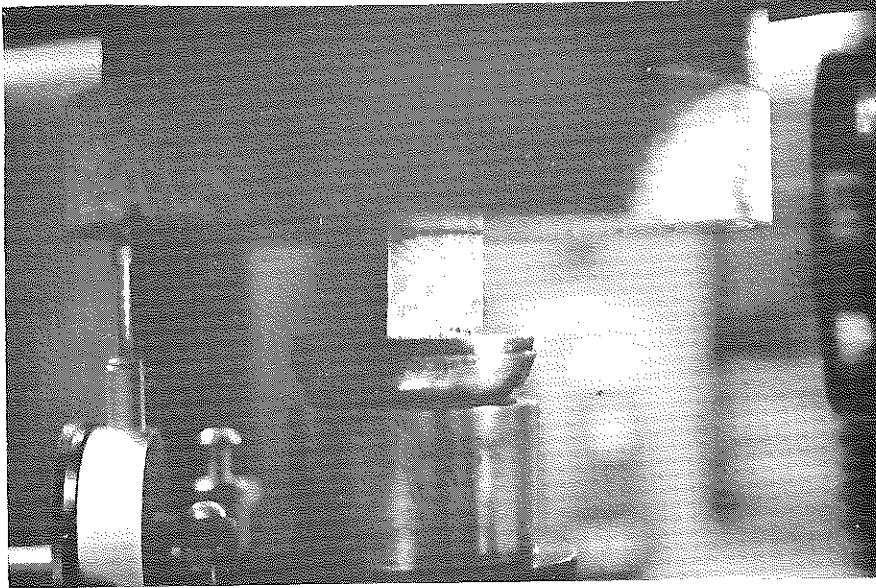
Fig. 2: Specimen of Bright White Oak in Compression. Note weeping from pores near base of specimen.

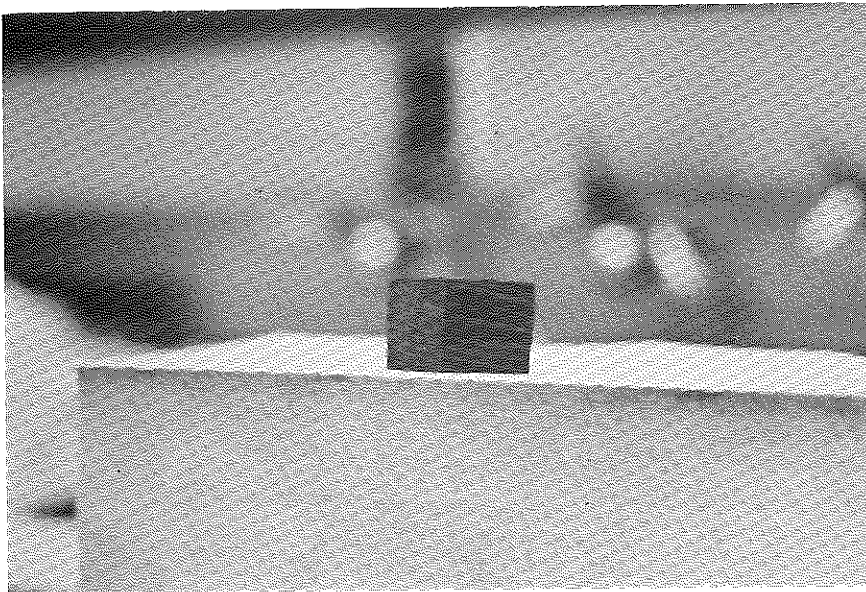
Fig. 3 shows a specimen of dark wood distorted (residual) by compression. None of the specimens ruptured, split, or tore; all specimens, including new wood, exhibited a yield point followed by strain hardening. The resulting stress-strain relationships are shown in Fig. 4. The minimum yield point occurred at about 350 psi; the yield stress of new wood was in the order of 2 to 2.5 times that of old wood. The handbook yield point for white oak, at 70% moisture (green and unseasoned), is 850 psi.

Fig. 3: Dark White Oak Specimen Showing Residual Distortion Following Severe Compression.

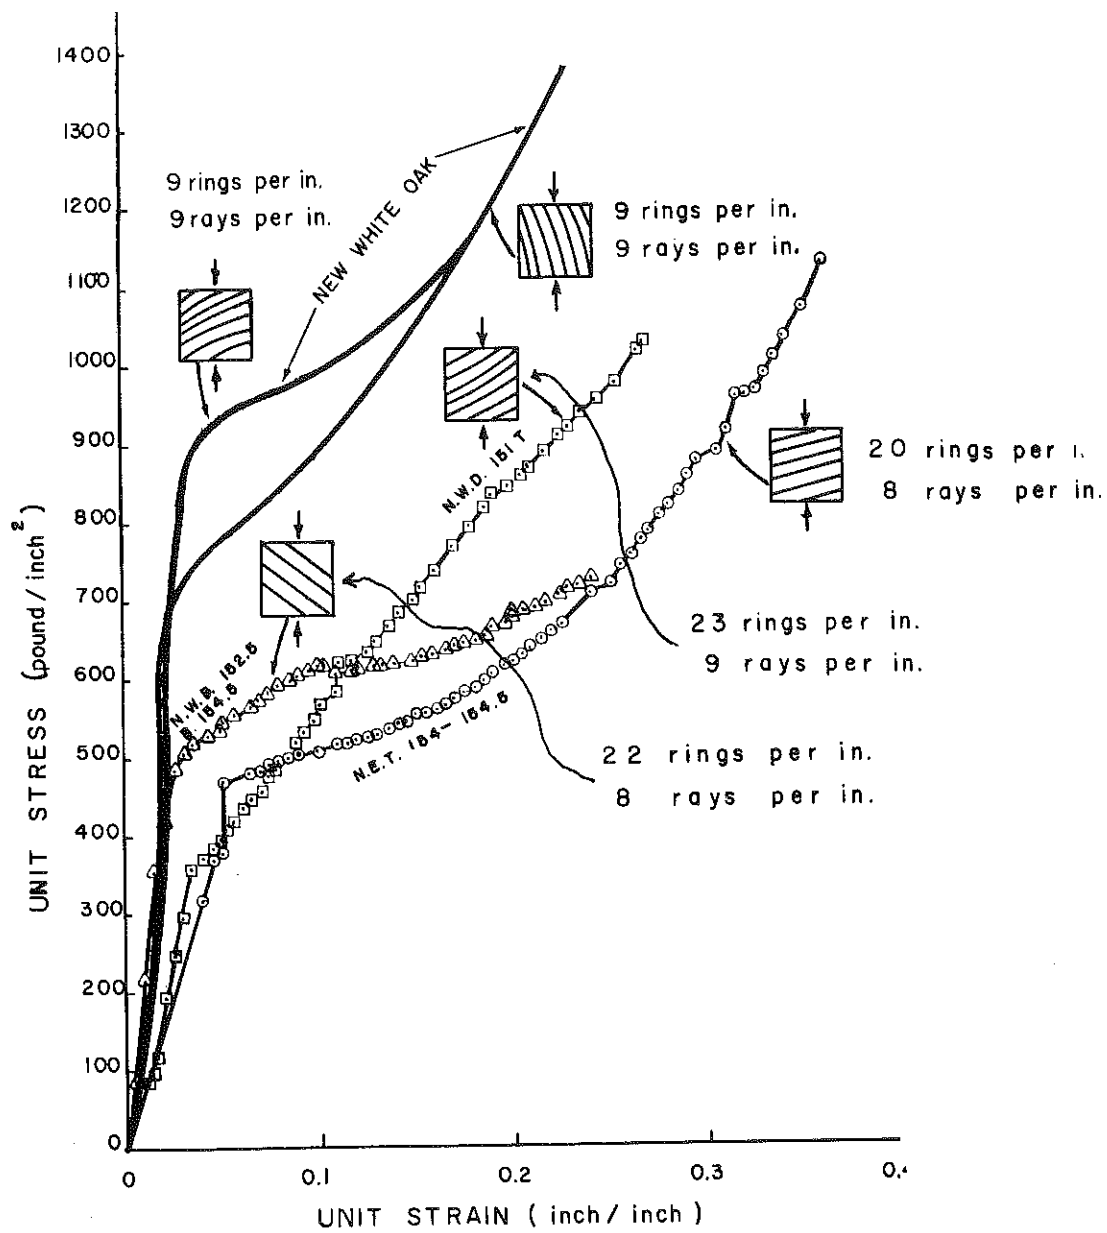
Fig. 4: Stress-Strain Relationships Obtained from Old Wood and New Wood (saturated).

The simple compression tests and the relaxation moduli indicated an apparent loss of strength in comparison to new wood. If it were assumed that the old wood was originally as strong as the new wood, the differences in strength might be attributed directly to age, deterioration, decay, etc. However, there are significant reasons, based on anatomical or structural comparisons, to suspect that the new wood is superior to the original quality of the old wood and that interpretation of strength differences as a loss in strength of the old wood is not altogether justifiable. The old wood contains about twice as many porous rings per lineal inch as the new wood. Strength varies in some inverse proportion to the number of rings per inch -- probably more discretely with the percentage of the area occupied by large pores. Visual comparison of Fig. 9 with Fig. 11 suffices to show that the new wood and old wood are not identical in these dimensional attributes. A cursory ratio of 2:1 would, indeed, minimize the strength loss attributable to deterioration of the old wood -- that is, if wet-strength loss is used as an estimate or measure of deterioration. Air-dry strengths further minimize the extent of deterioration.

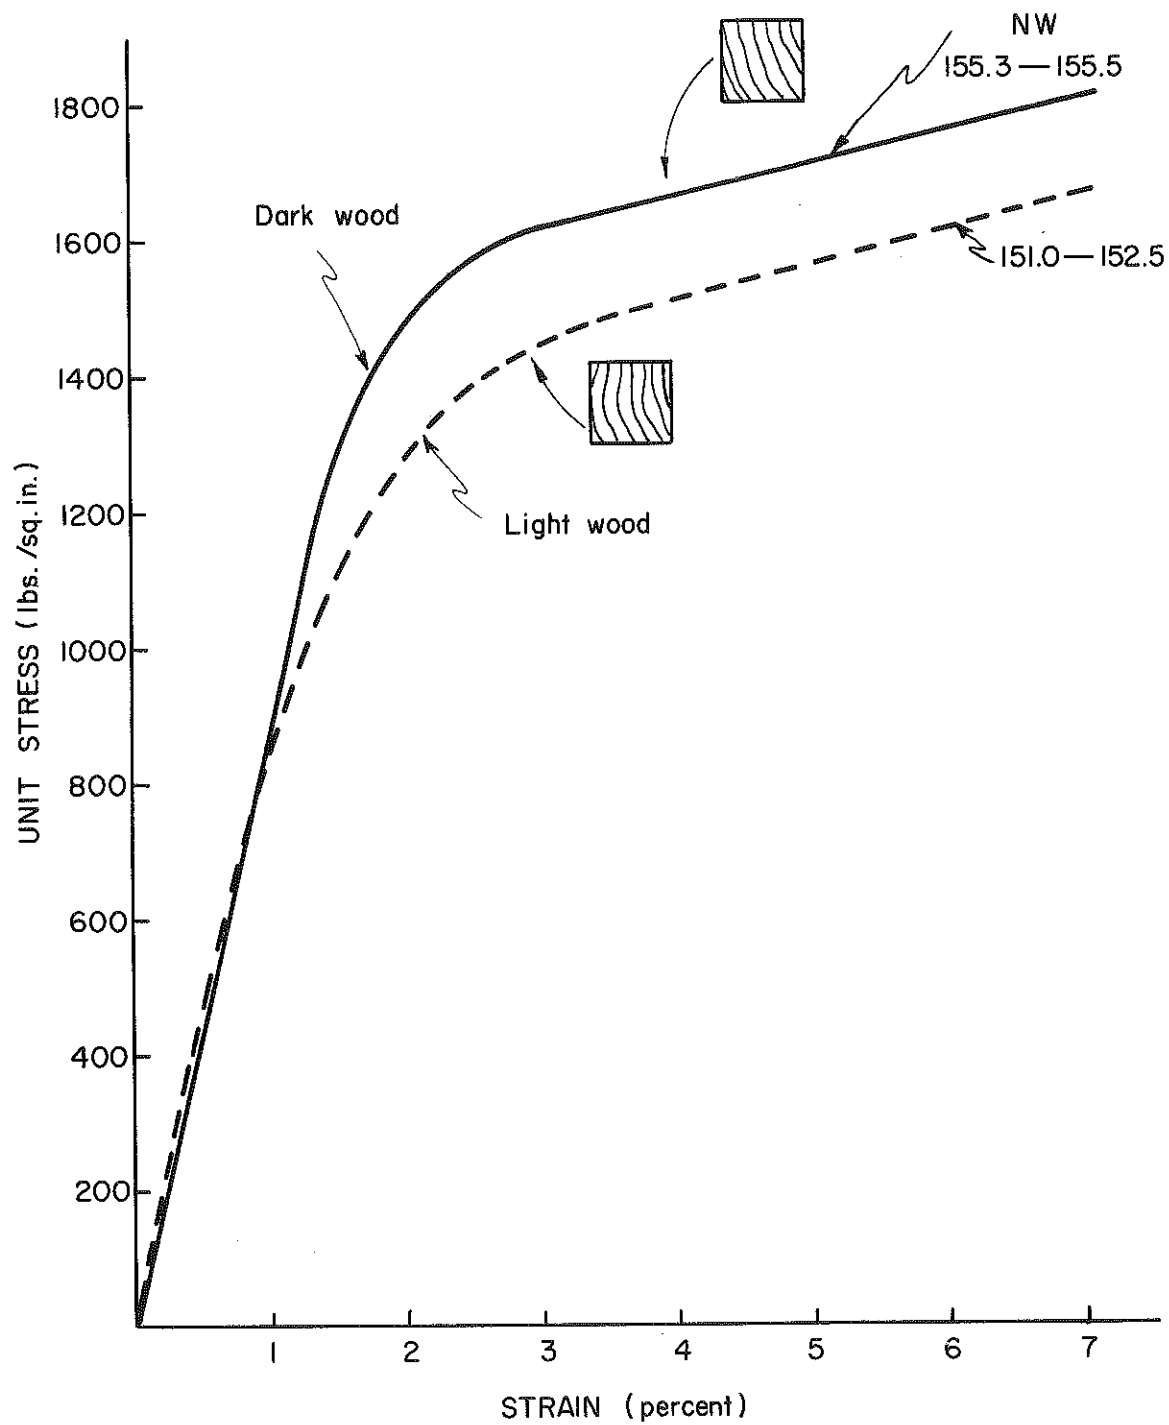
Fig. 5: Stress-Strain Relationship Obtained from Air-Dry Specimens of Old Wood.

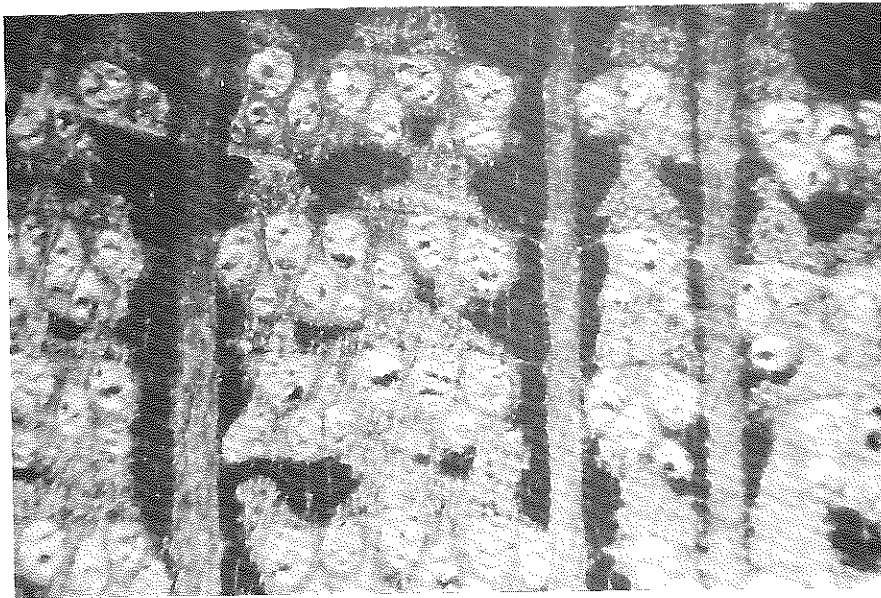
Fig. 11: Cross Sectional View of Dark Wood from Pier No. 2, Magnified 17.5X. Note greater abundance of large pores; specimen contains 17.5 rings per inch and 10 rays per inch.

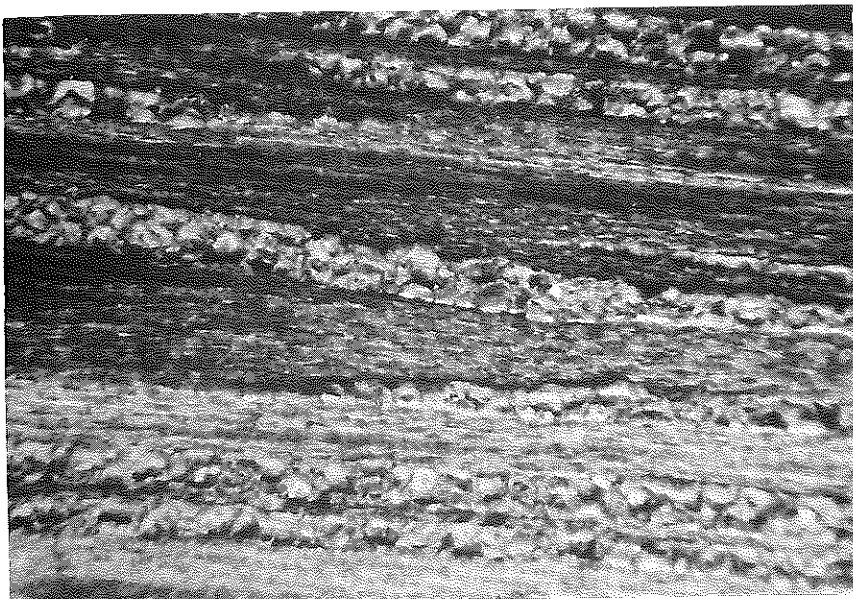
Fig. 12: Side View of Dark Wood from Pier No. 2, Magnified 17.5X. Greater abundance of large pores are evident here also.

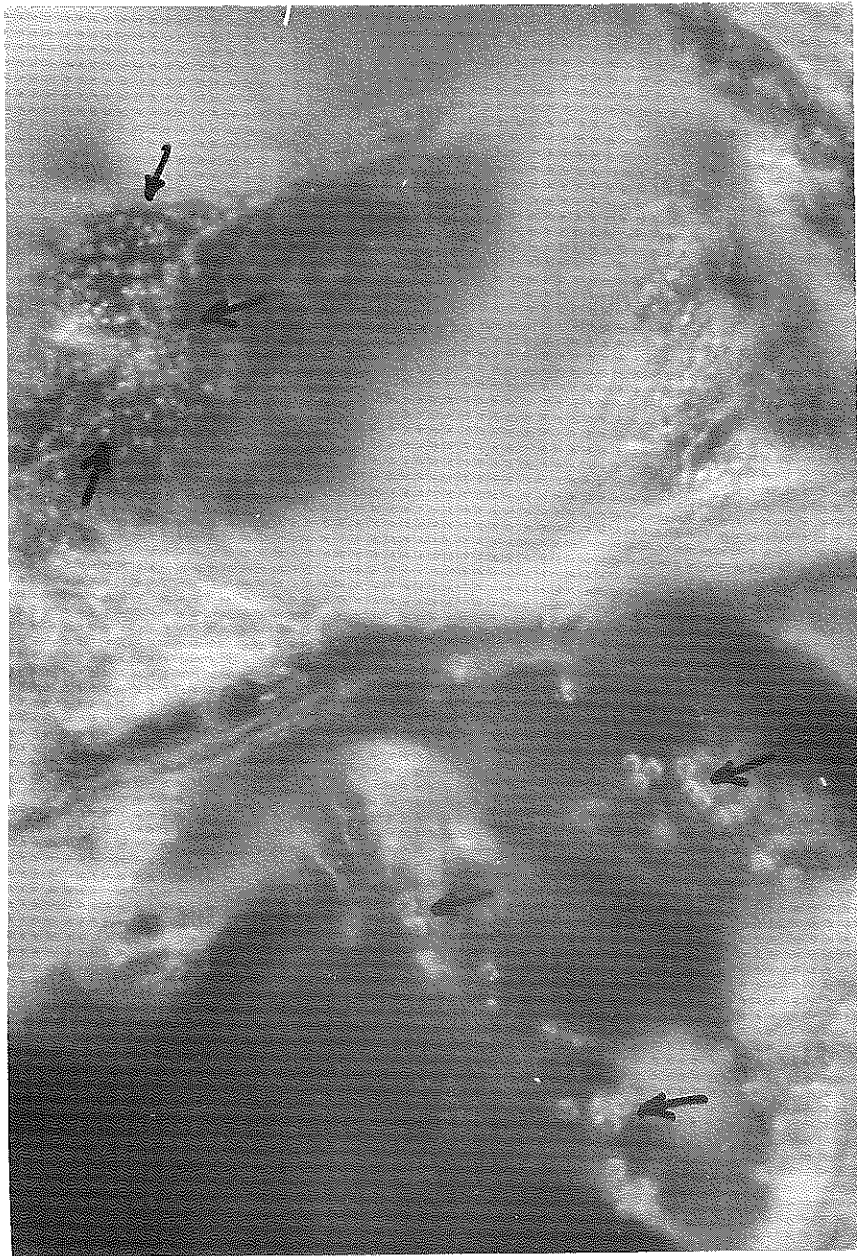
Careful appraisal of the material prepared for microscopic examination showed bacteria commonly present in all samples (see fig. 1). Assigning specific cell-wall deterioration in the wood to these organisms has not

Figure 1.--Bacteria supported on tylosal membranes in vessel cells of white oak samples. This particular slide was prepared from oak core sample taken at the 152.0-foot level, but such bacterial infections were common throughout all the sample materials examined. Notice the two sizes of bacteria present, both coccus forms but distinctly different in size. Bacteria observed microscopically were consistently of the coccus form (1200X).

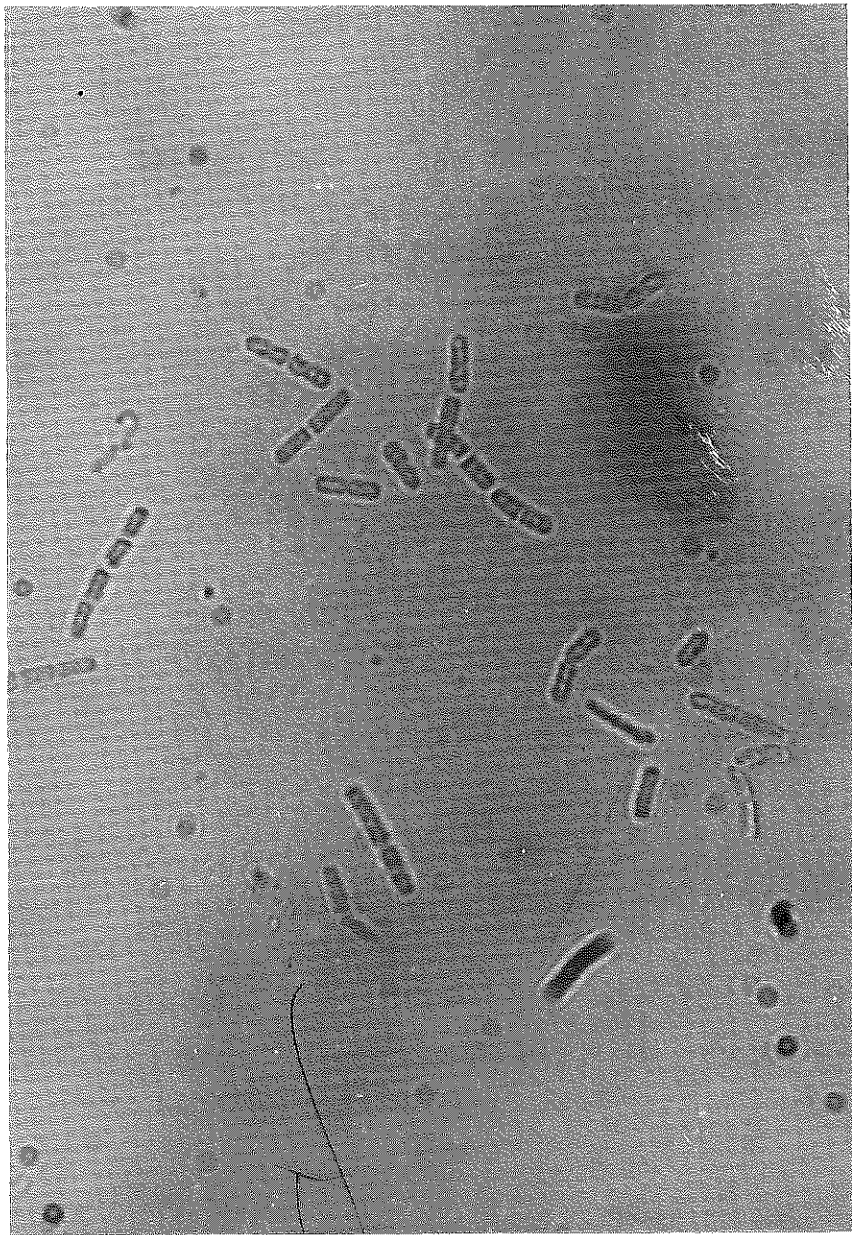
All of the bacteria observed microscopically in the wood sample sections appeared to be coccus forms. All 32 cultured isolates obtained from the randomly sampled grillage cores are rod forms of bacteria (see fig. 2). This suggests that the alcohol solution used for protecting the cores may have killed the coccus forms, observed microscopically, and permitted the culture recovery of only a comparatively resistant or spore-forming rod form.

Figure 2.--Bacteria from one of numerous cultures obtained by isolation attempts from the grillage samples. Similar cultures were obtained from all samples. These bacteria were consistently found to be short rod forms occurring either singly or in short chains. No coccus forms of bacteria were obtained in culture. The absence of living coccus bacteria in the samples is thought to be due to the alcohol pickling of the wood samples.

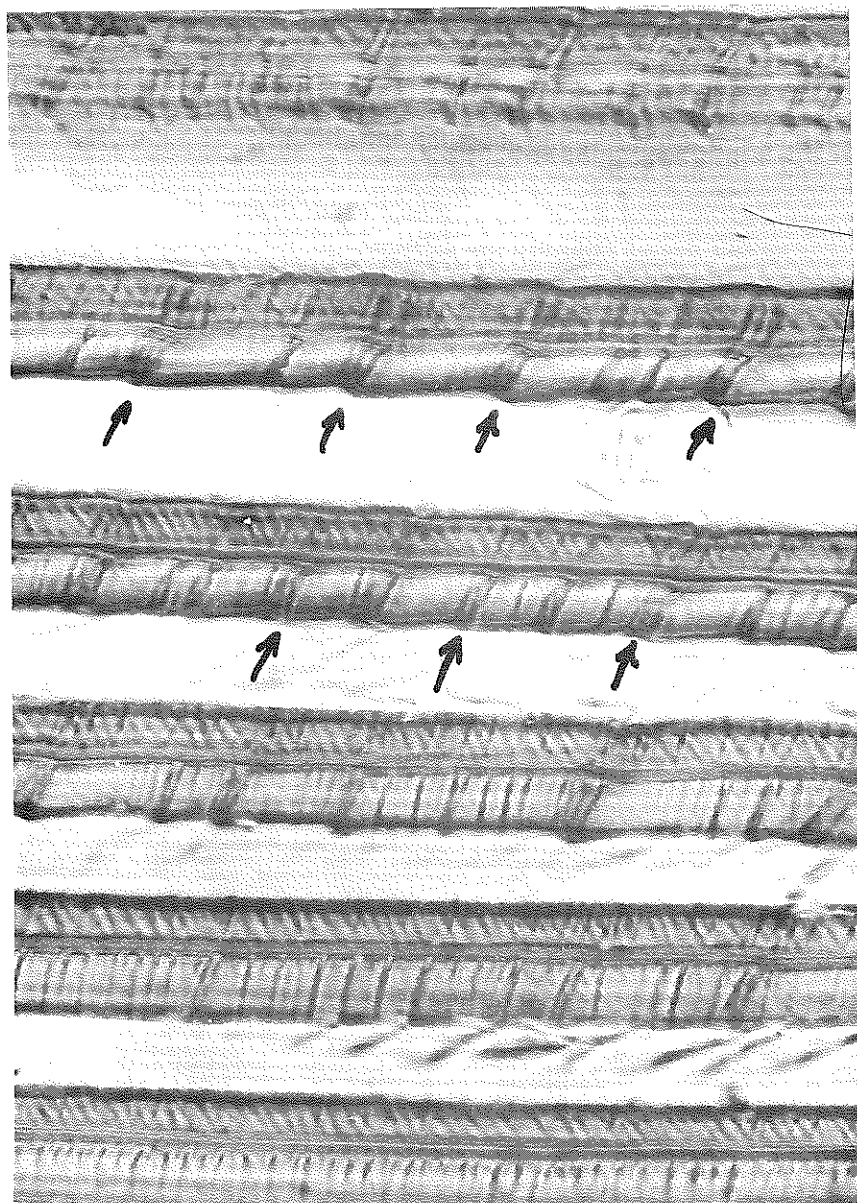
Ruptures in the cell walls representing compression failures (fig. 3) were rather common, but it was impossible to establish the exact cause of such defects. Possibly, these failures could have resulted from the twisting action of the core-boring process referred to above. Also, longitudinal separation of the wood cells along the primary walls was observed at infrequent points. This, too, could have resulted from the same cause, although material was selected for slide preparation that was free of visibly apparent defects thought to have been induced by the coring process. Alternatively, bacteria, actinomycetes, or soft-rot fungi, capable of preferentially attacking lignin, could possibly account for abnormal weakening of the primary wall and consequent failure under torque loading since the primary wall is predominantly lignin.

(5) Rupture of a compression-failure type in the secondary wall of some wood cells was moderately common and separation of adjacent rows of oak fibers along the primary wall was also observed in several samples. Whether these forms of damage were due to biologically or chemically degraded wood or to the mechanical stresses imposed by core boring was not determinable.

Figure 3.--Radial section of oak from a depth of 155.5 feet showing cell-wall compression failures. This physical defect could not specifically be attributed to any single or combination of causes with certainty, but such faults represent a significant decrease in strength. See text for possible explanation of cause (1200X).

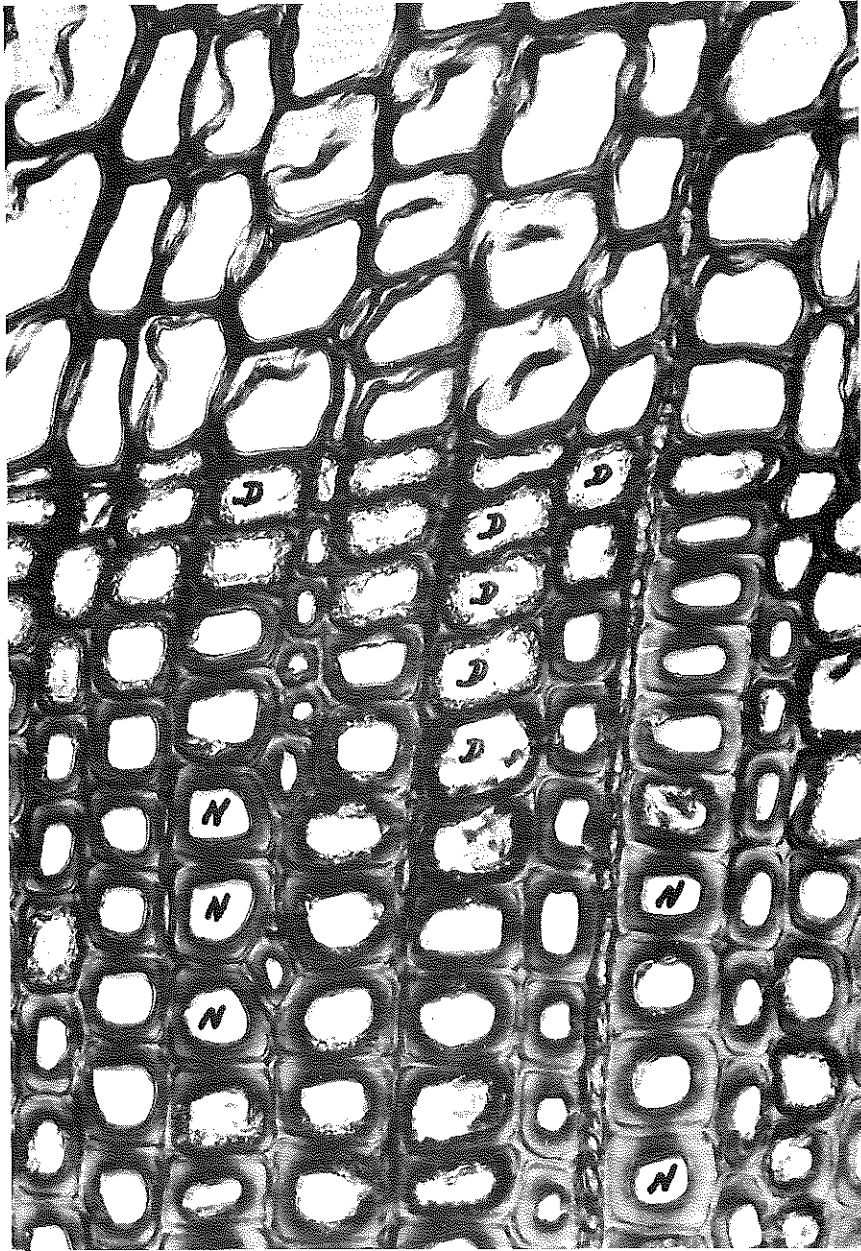
been possible, although some instances of biological degrade of the wood were noted in the pine sample (see figs. 4 and 5). This type of damage was observed to be present in varying degrees in the latewood cells of most annual rings in the pine that was inspected. Such degrade could be particularly significant in strength loss if generally present in extensive areas of the grillage members. No filamentous fungi were detectable in association with this degrade, but more sampling will be necessary before a reliable appraisal of the pine present in the grillage can be made.

Figure 4.--Cross section of pine sample (156.5 ft.) showing cell-wall deterioration in the last three to 10 tracheids of an annual ring. This condition was observed repeatedly in this sample and may be due to biological (enzymatic) breakdown of the secondary cell wall. Whether such action has been the result of fungal or bacterial action was not determined, but from a practical point of view, it makes little or no difference--the end result is weakening of the wood. Normal cells are designated by N, deteriorated cells by D (380X).

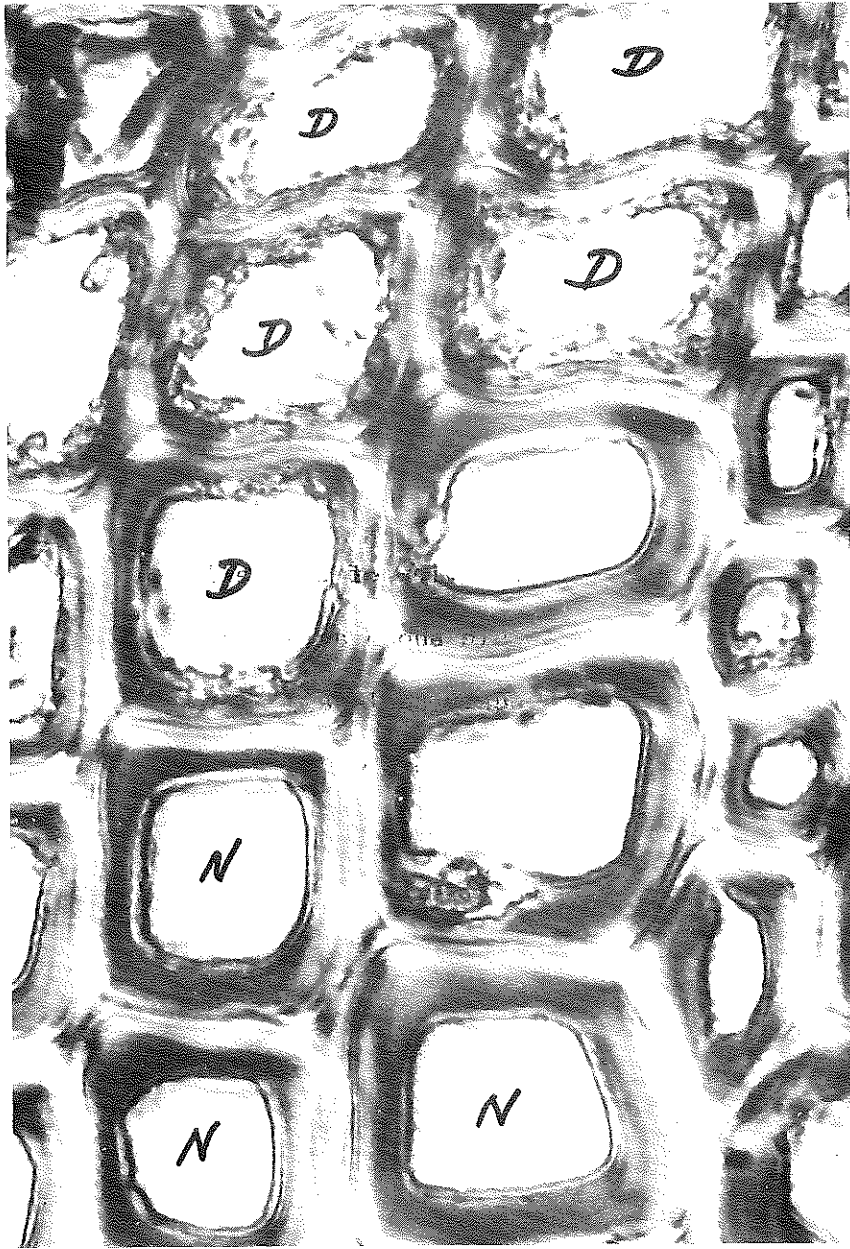
Figure 5.--A second view of the cell-wall deterioration in the pine sample shown at a greater magnification (1200X). Secondary cell-wall material deteriorated in cells marked D, cell walls normal in cells marked N.
